**STORM SEWER
ASSET MANAGEMENT PLAN**

BERGLAND TOWNSHIP

NOVEMBER 2018

**COLEMAN ENGINEERING COMPANY
ON BEHALF OF BERGLAND TOWNSHIP**

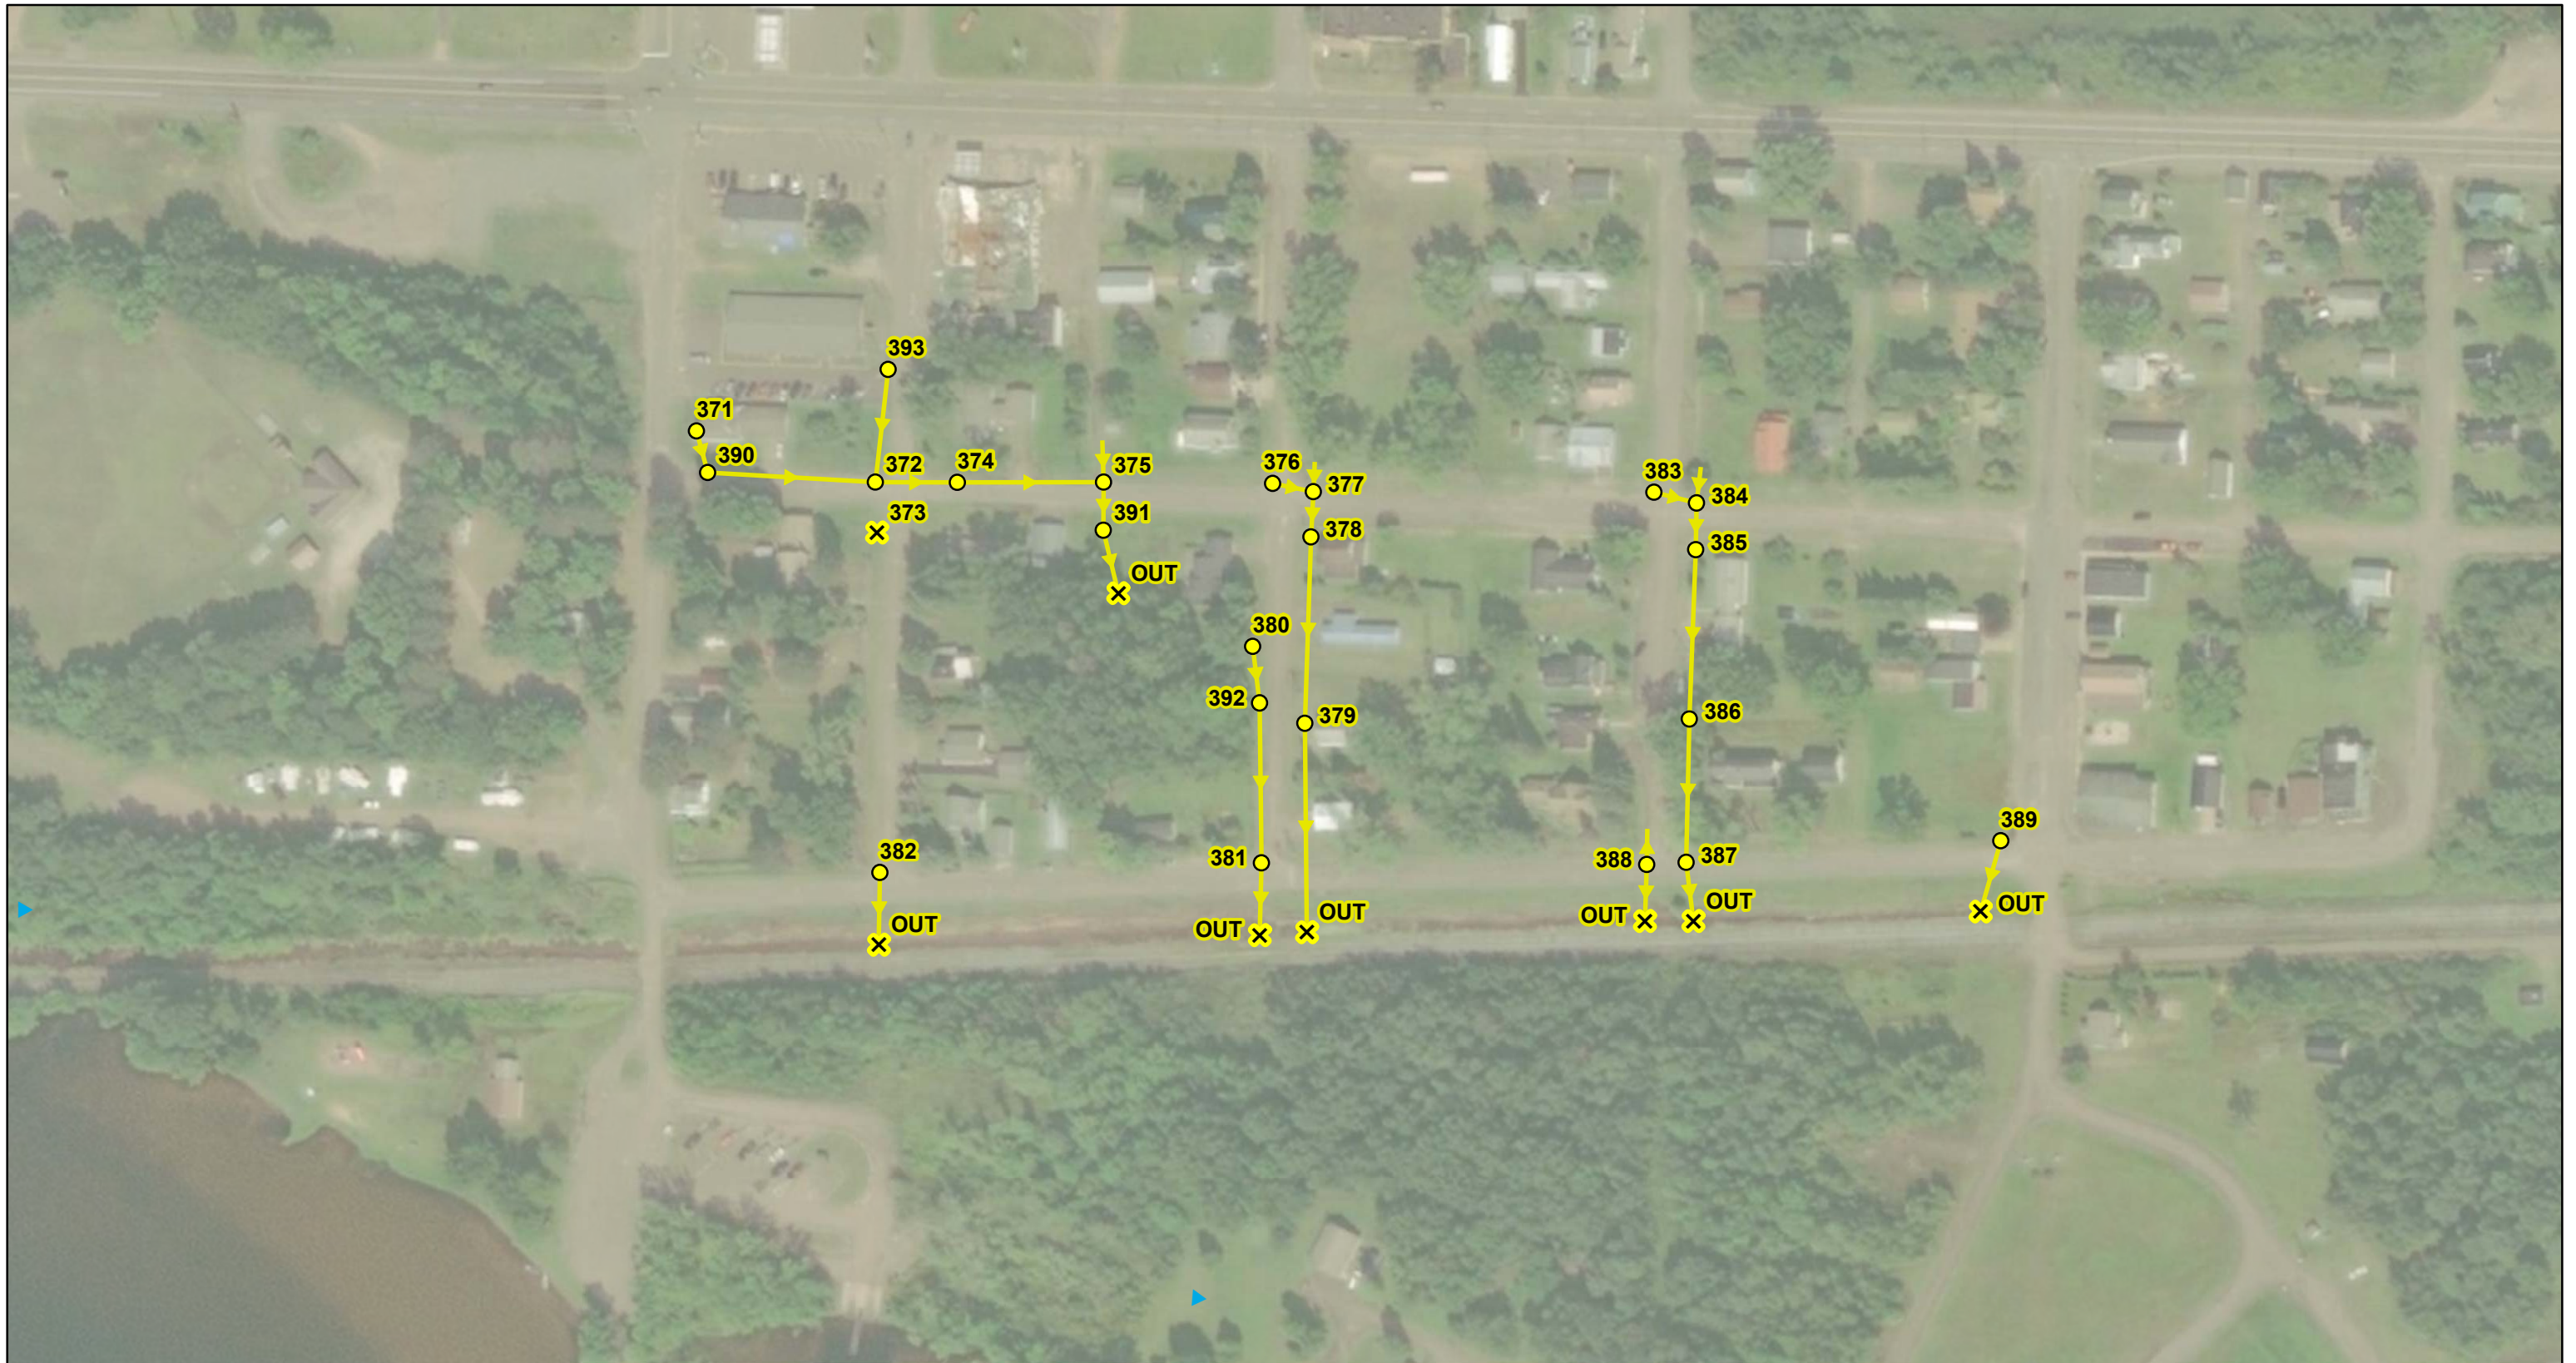
Figure A2 - Bergland Township Storm Sewer System

- Storm Sewer Structure
- ✕ Unlocated Storm Sewer Structure
- Storm Sewer Main

- Figure A1 Bergland Township - Location Map
- Figure A2 Bergland Township Stormwater System Map, Page 1
